Paddle-shift Manifold Isolation

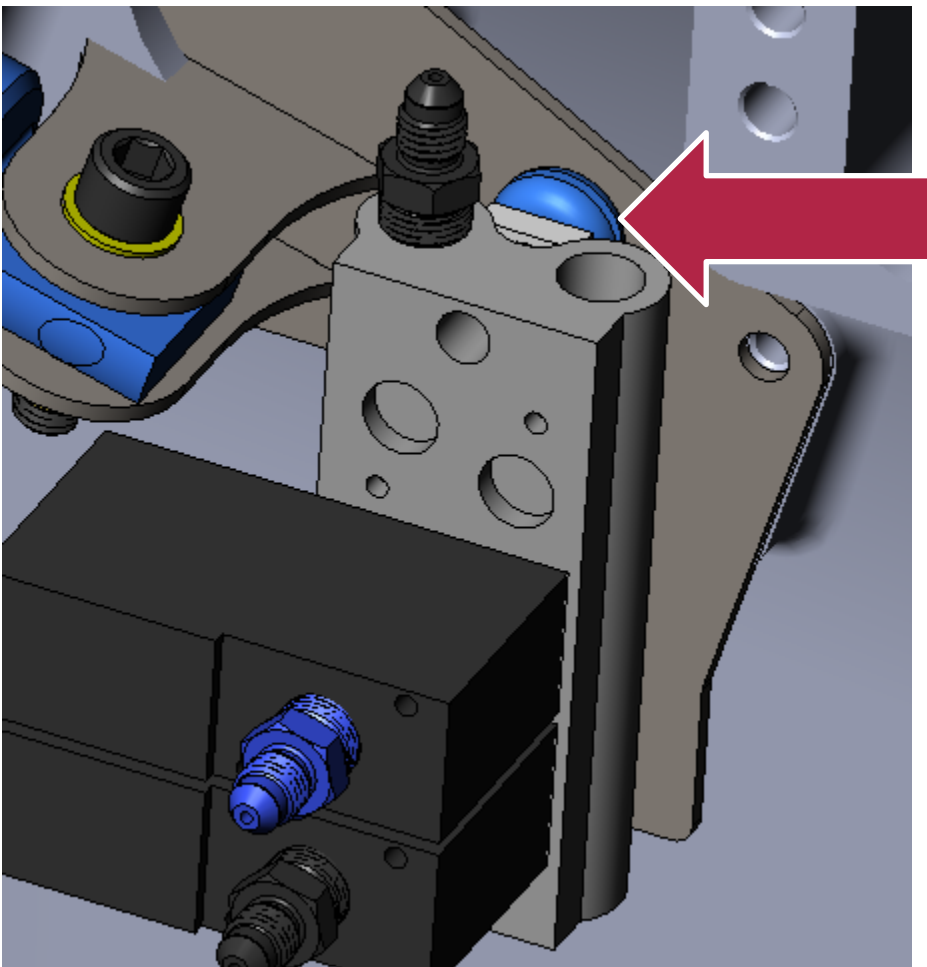
It has been found that several occurrences of contact/connectivity issues in either the shift pressure sensor or shift pressure sensor connector can cause erratic pressure readings, resulting in denied shift requests or odd pump behavior.

It is advised to isolate the paddle-shift manifold (aluminum block pictured below) from vibration using McMaster-Carr 9311K127 or similar between the manifold and its mounting surface. Note: Do not isolate the mounting plate to the gearbox, this will negatively affect the shift actuator.
