F4 DI HP Fuel Pump Bolt Failures Technical Bulletin # F4-2018-EN003

This Technical Bulletin contains information regarding potential issues with the F4 engine Direct Injection High Pressure Fuel Pump Bolts.

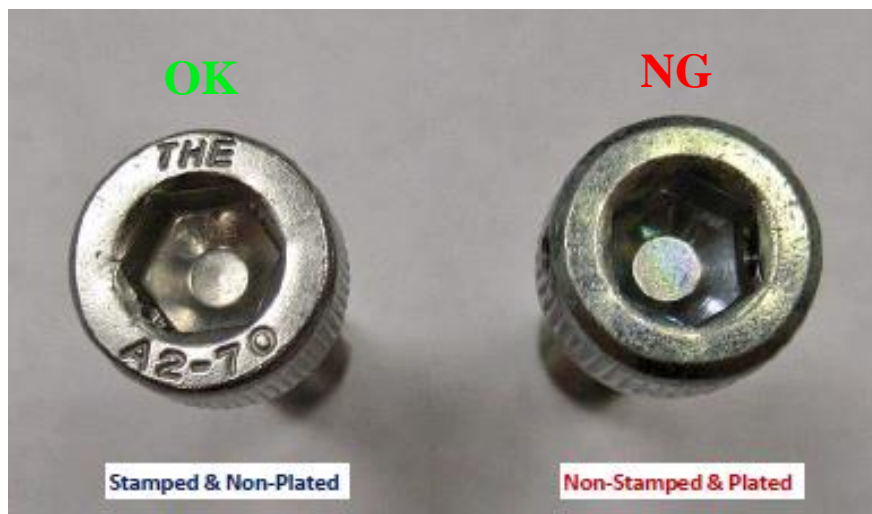
HPD has identified a potential issue with the DI high pressure fuel pump bolts on the F4 engine. There have been 2 types of bolts identified in the field. The first type is stainless steel and has an identification mark stamped on the head of the bolts. The suspect bolts have a tinted zinc plating and no identification stamps on the head of the bolt. The suspect bolts have been found to fail under load, potentially leading to a fuel line failure and large fuel leak.

Teams are advised to inspect their cars, and notify HPD if they find any of the non-stamped, plated bolts. It is also advised to cut the seals and check torque on all bolts. Torque specification is **13 Nm**. **DO NOT over-torque the bolts**. HPD will re-seal all pumps and replace any of the suspect bolts at the Mid-Ohio F4 race.
