RAIN LIGHT UPDATE 08-12-038

FIA Type 1 Mandatory Update

PN: 08-12-038 RAIN LIGHT

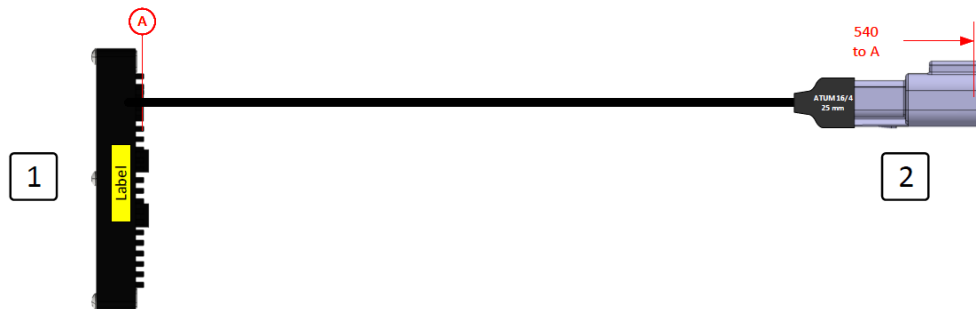
Following safety reviews by sanctioning bodies and the FIA, a flash pattern will be initiated in the event of an engine stall on the starting grid in order to alert the drivers behind. A stall flash is a higher frequency than the standard rain flash. The rain light flash sequences will now be controlled by the ECU. The rain light must be replaced to achieve this.

For the JS F4, the mounting location will change to the back of the attenuator instead of the bracket on top of the attenuator. Please use PDF template **F4 RAINLIGHT TEMPLATE** to locate drill holes.

Any car using early production gearbox harnesses will likely require a rain light extension harness, available from Ligier. Gearbox harnesses CCF4-13-110 **B** will not require the extension.

ECU's must be updated to the latest firmware for correct rain light functionality. Please coordinate ECU updates with HPD.
