# PVC Pro Channel Tracking Problem

## Bug Fix Guide

Some PVC Pro passive volume controllers have had a problem with channel tracking due to an unfortunate manufacturing bug. Usually this will show up when you turn the volume knob all the way down, and you can still hear a faint sound coming out of the right speaker. Luckily this can be fixed very easily by following the instructions below. If in any case you have any doubts or you have more questions about this guide, please feel free to contact us by phone at 707.747.0122 or by email [engineering@nhthifi.com](mailto:engineering@nhthifi.com).

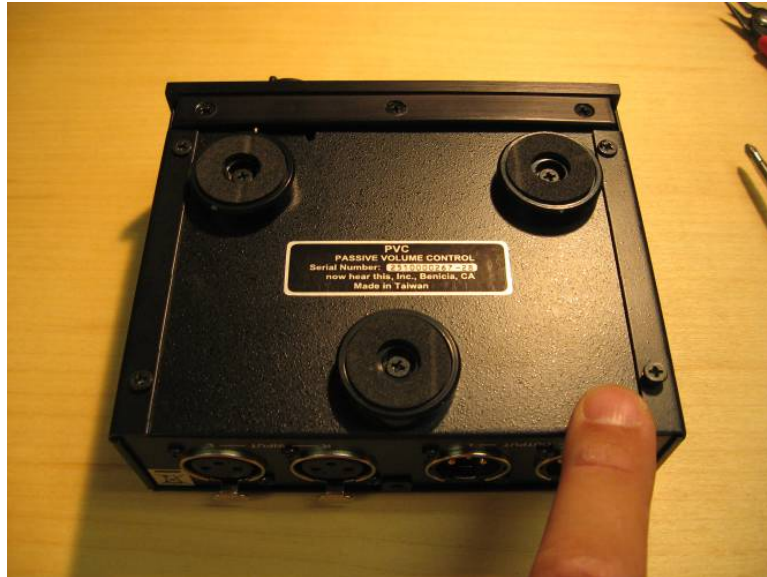
- a. Remove the four cover screws located at the bottom and the one located between the input and output connectors on the back of your PVC.

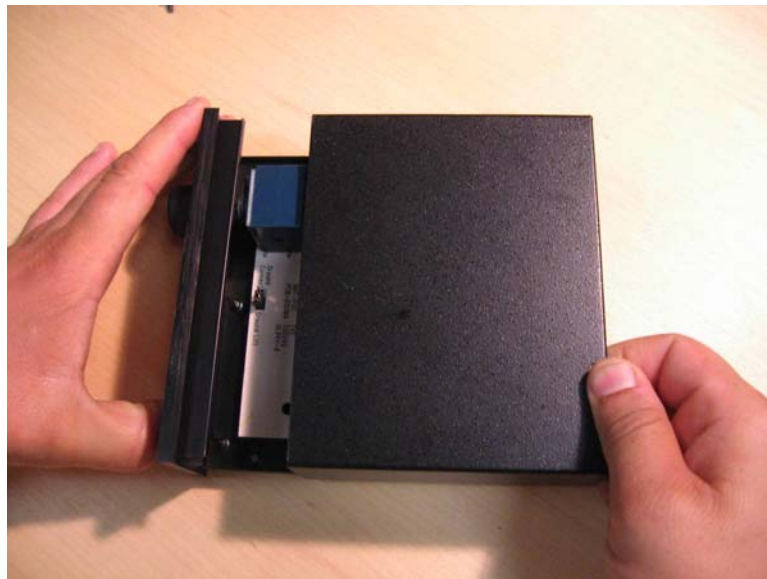
- b. Slide the cover off. It might be little tight, so be careful!

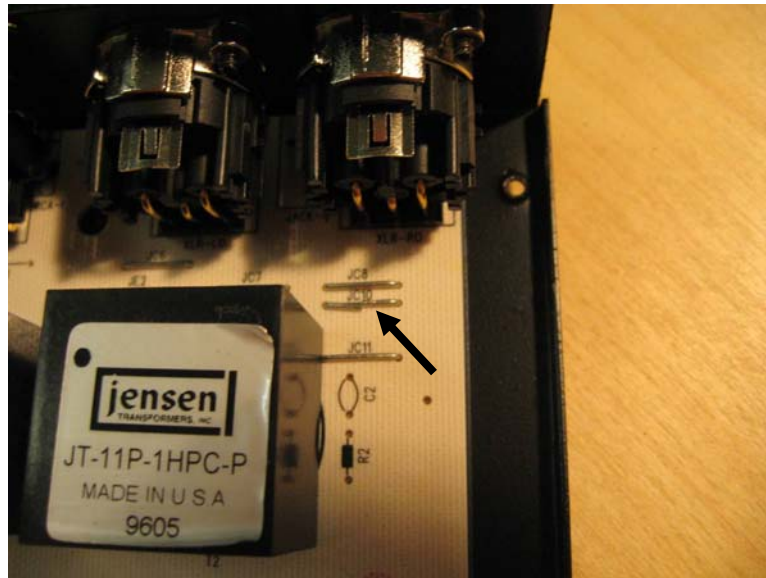
- c. Find the jumper connector JC10 from the board. It is located just behind the right output connector.

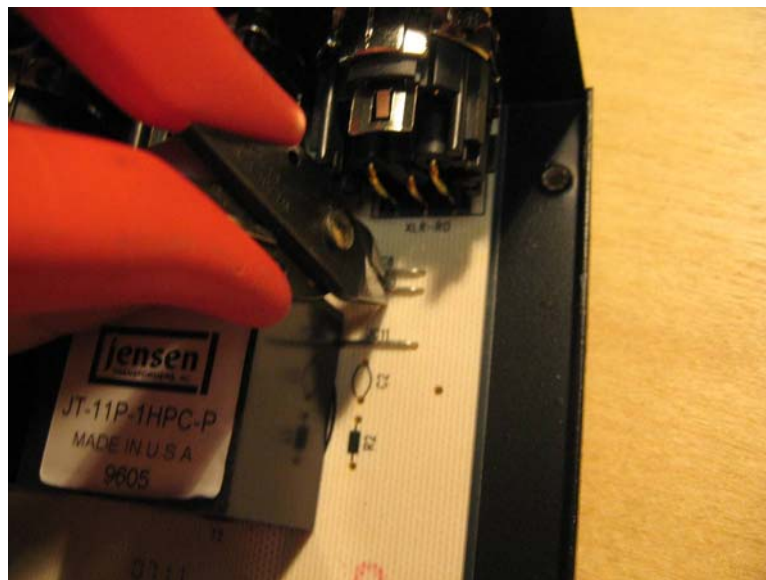
- d. Using your wire cutters, cut the jumper off.
