## **CRAWFORD F4**

**Bulletin F4.17.06.27**

**Wheel nut washer CCF4-17-006**

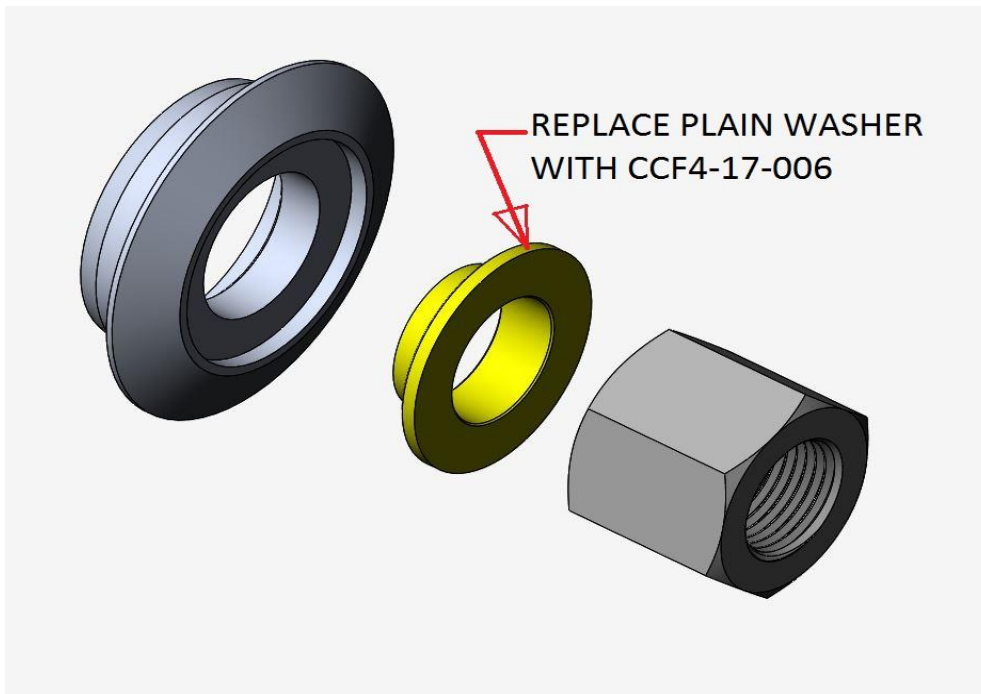
We have noticed that the plain washer under the wheel nut is liable to deform after usage.

Replace plain washer with CCF4-17-006. This will eliminate the deformation
