# Cam Cover Breather Safety

## Technical Bulletin # F4-2020-EN004-00

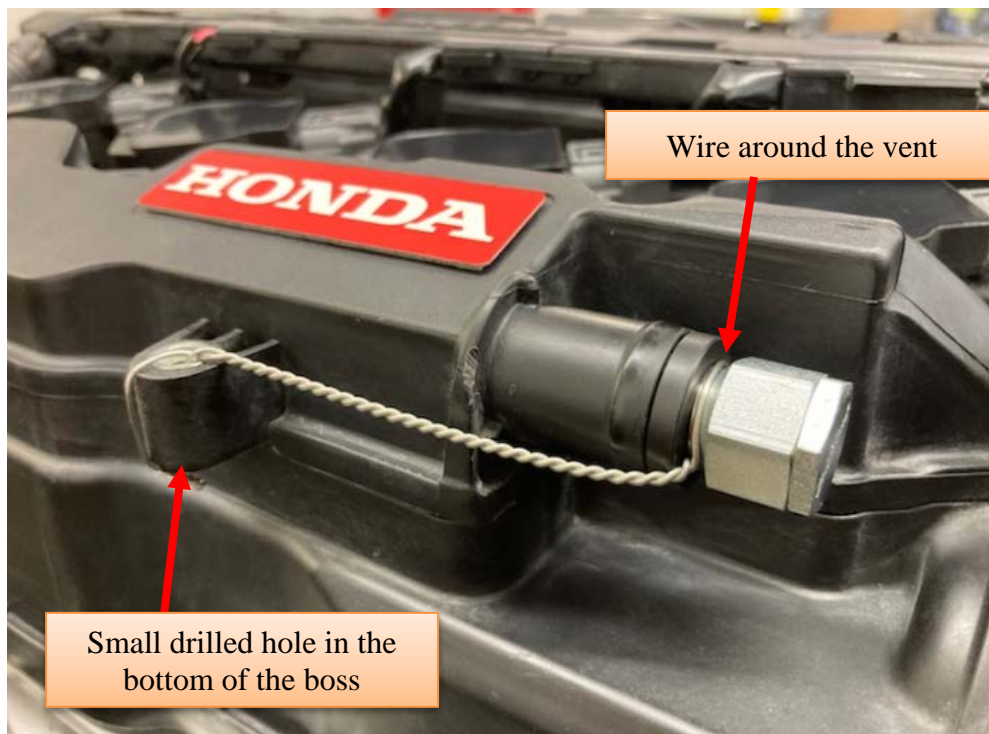
After the implementation of the cam cover breather for the 2020 season, there have been instances where the breather assembly has come out of the cam cover and been lost on track. This can cause a significant amount of oil to leak from the car as well as a possible small projectile exiting the rear of the car.

From the 2020 Barber event and onward, it will be required that the breather is properly safety wired to the cam cover as shown in the photo below. Competitors may need to drill a small hole in the bottom of the threaded boss as indicated to allow the wire to pass through. All cars must have this added safety wire at tech inspection for each event.
